**KAUNAS UNIVERSITY OF TECHNOLOGY  
FACULTY OF CIVIL ENGINEERING AND  
ARCHITECTURE BUILDING MATERIALS AND STRUCTURES  
RESEARCH CENTRE**

2020-07-22, No DV19-F-09-00051-26

**RE: EXPERIMENTAL FREEZE/THAW RESISTANCE TESTING ON CONCRETE  
PAVING BLOCKS  
MANUFACTURED BY UAB BETONO MOZAIKA AT FACTORIES IN VILNIUS,  
KAUNAS, KLAIPĖDA AND ŠIAULIAI AFTER 28, 56 AND 72 FREEZE/THAW  
CYCLES**

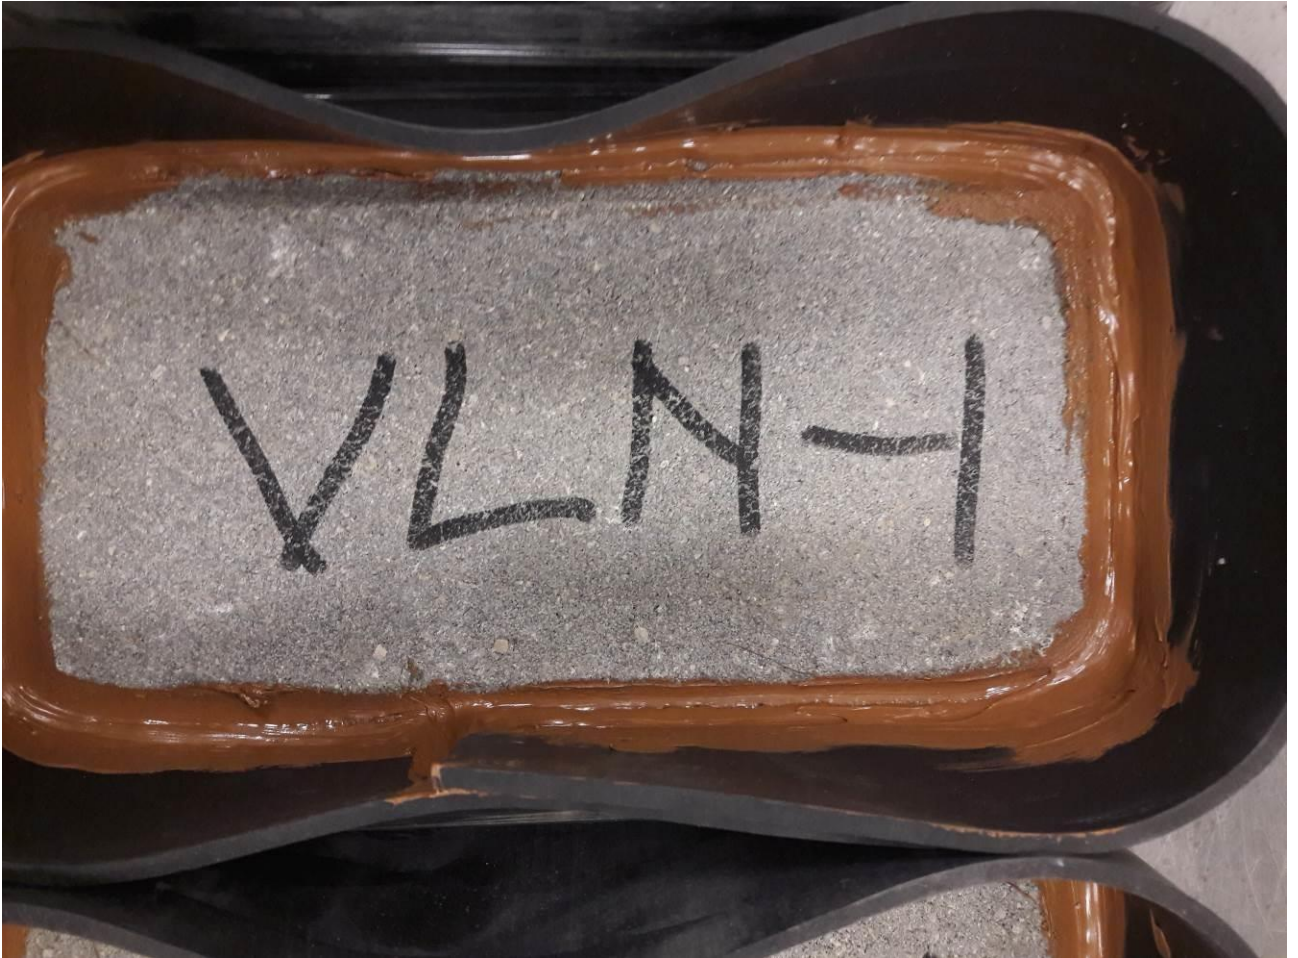
1 Figure Block VLN-1 before the freeze/thaw testing (top) and after 72 days of testing (bottom)

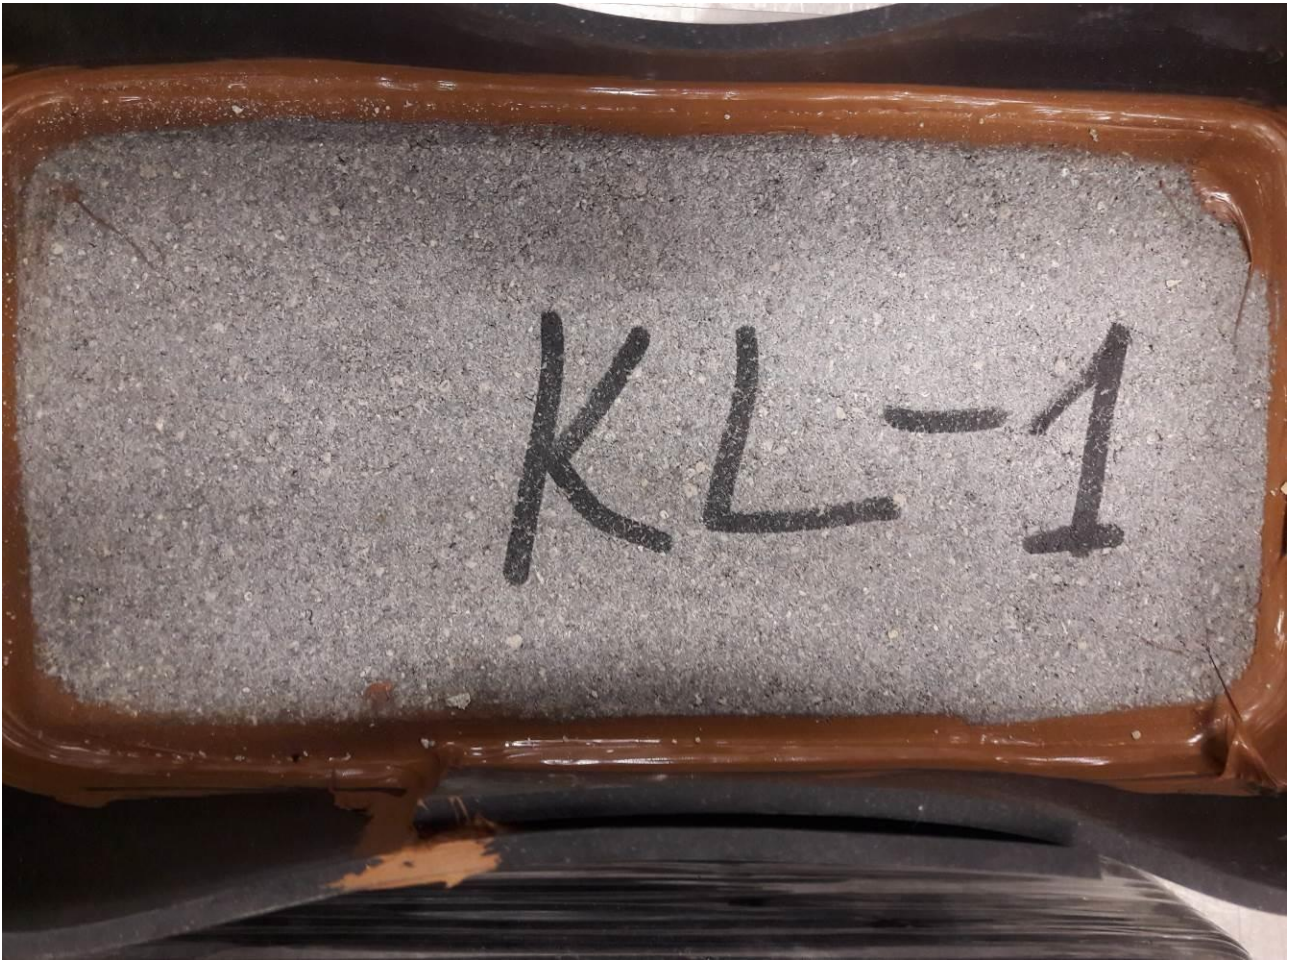
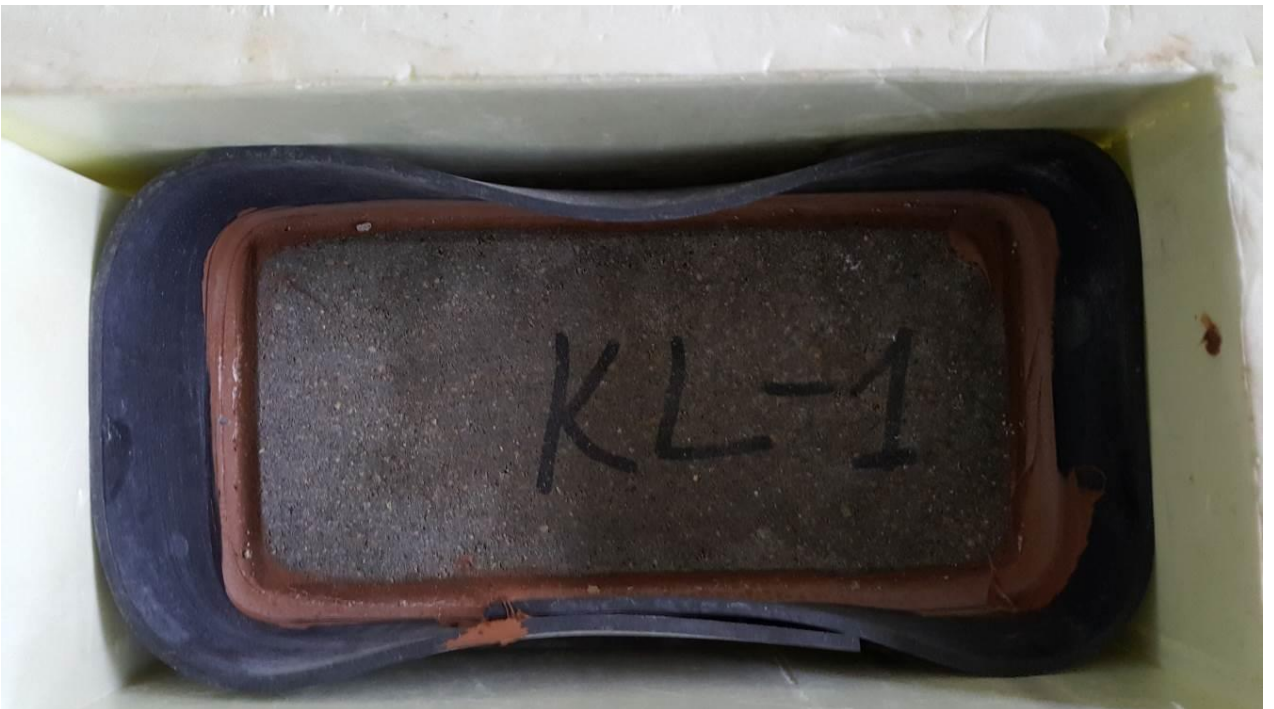
3 Figure Block KL-1 before the freeze/thaw testing (top) and after 72 days of testing (bottom)

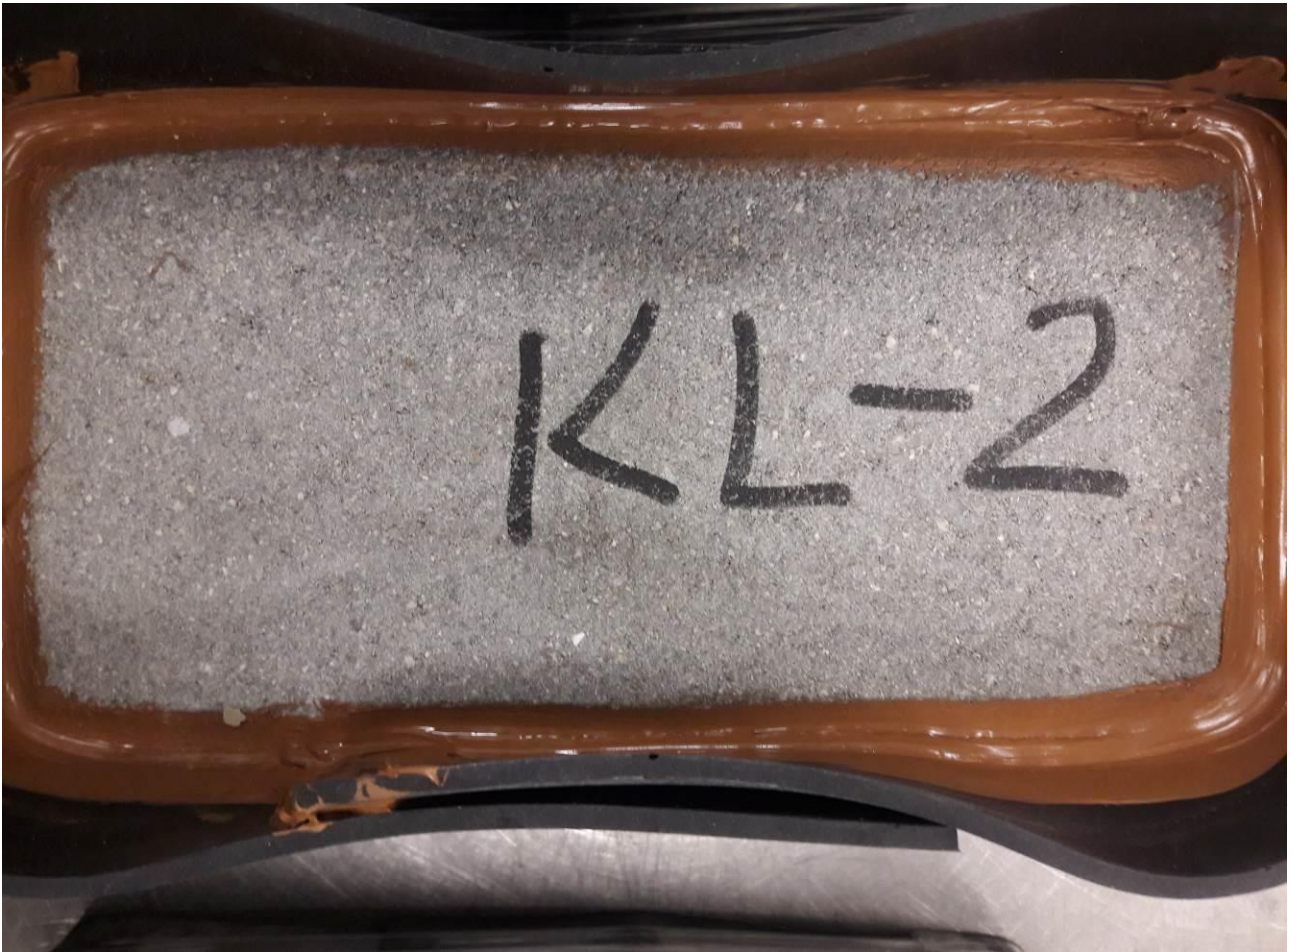
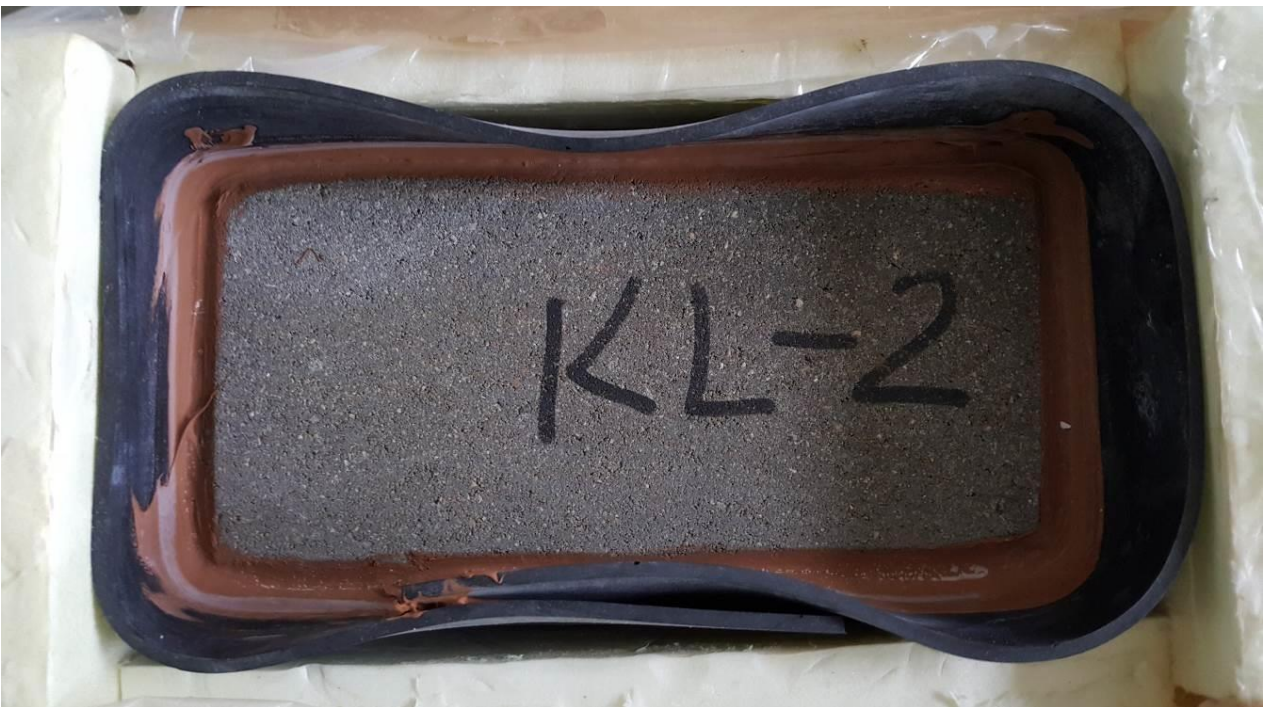
4 Figure Block KL-2 before the freeze/thaw testing (top) and after 72 days of testing (bottom)

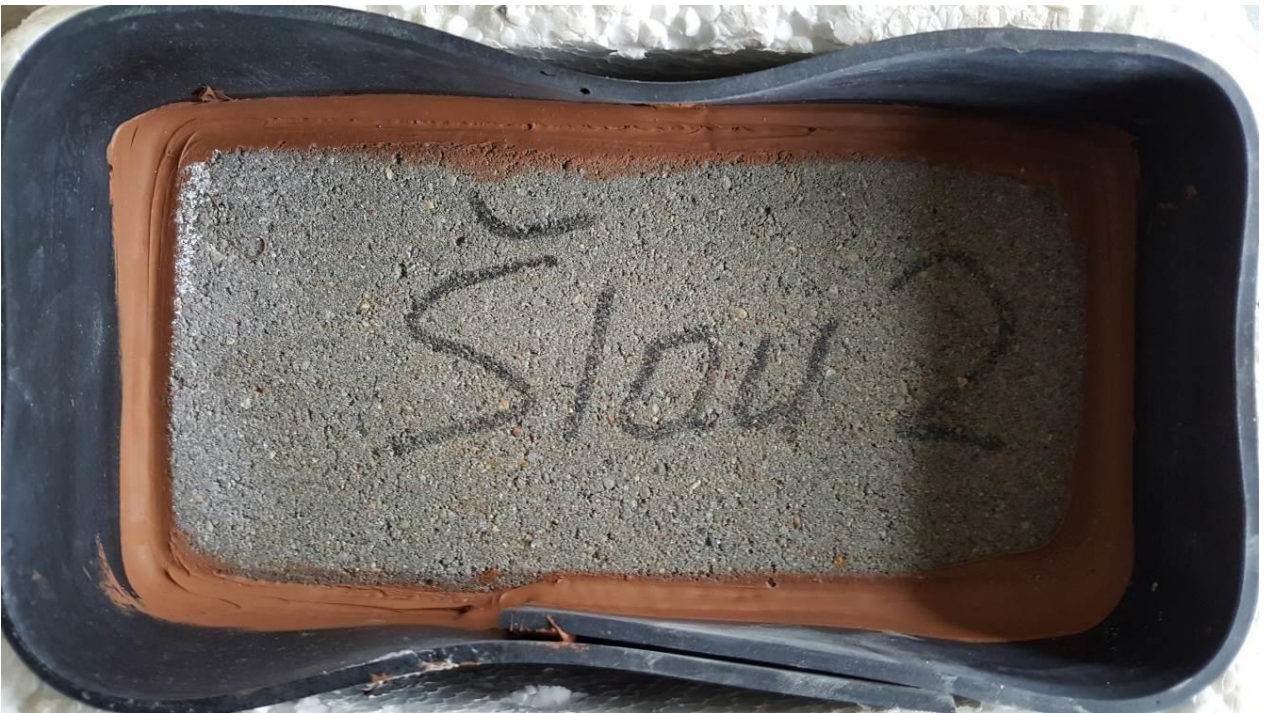
6 Figure Block Šiau2 before the freeze/thaw testing (top) and after 72 days of testing (bottom)

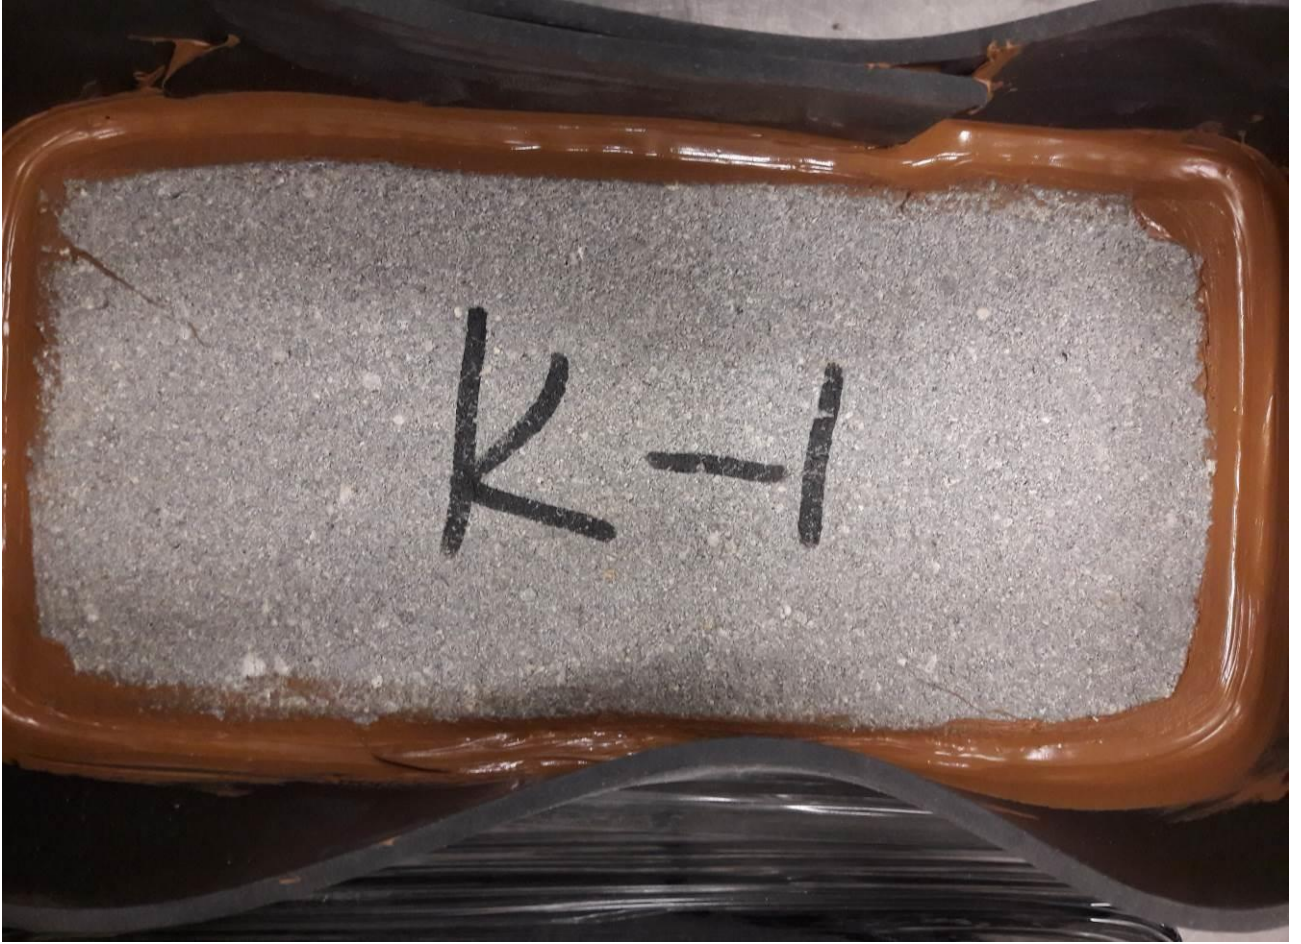
7 Figure Block K-1 before the freeze/thaw testing (top) and after 72 days of testing (bottom)

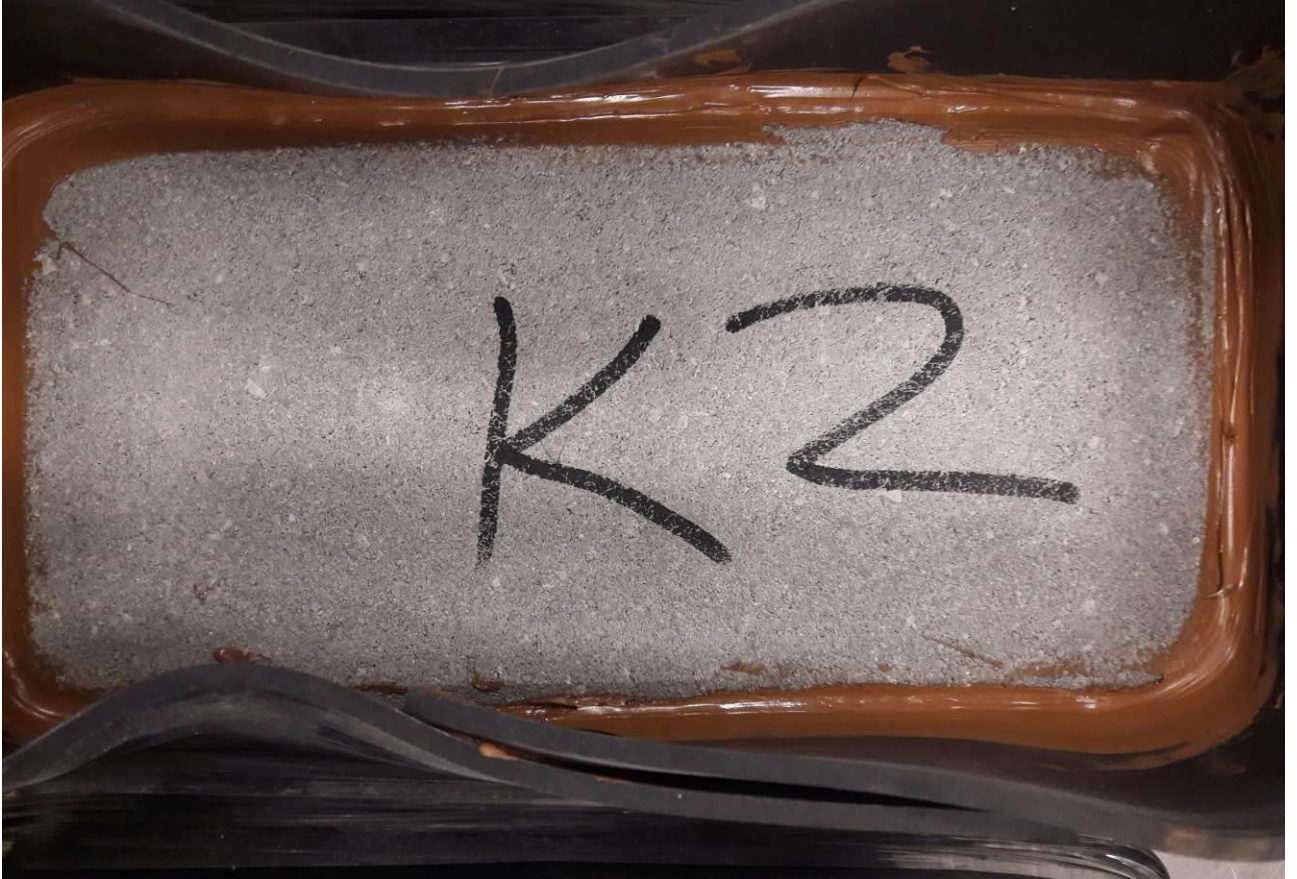
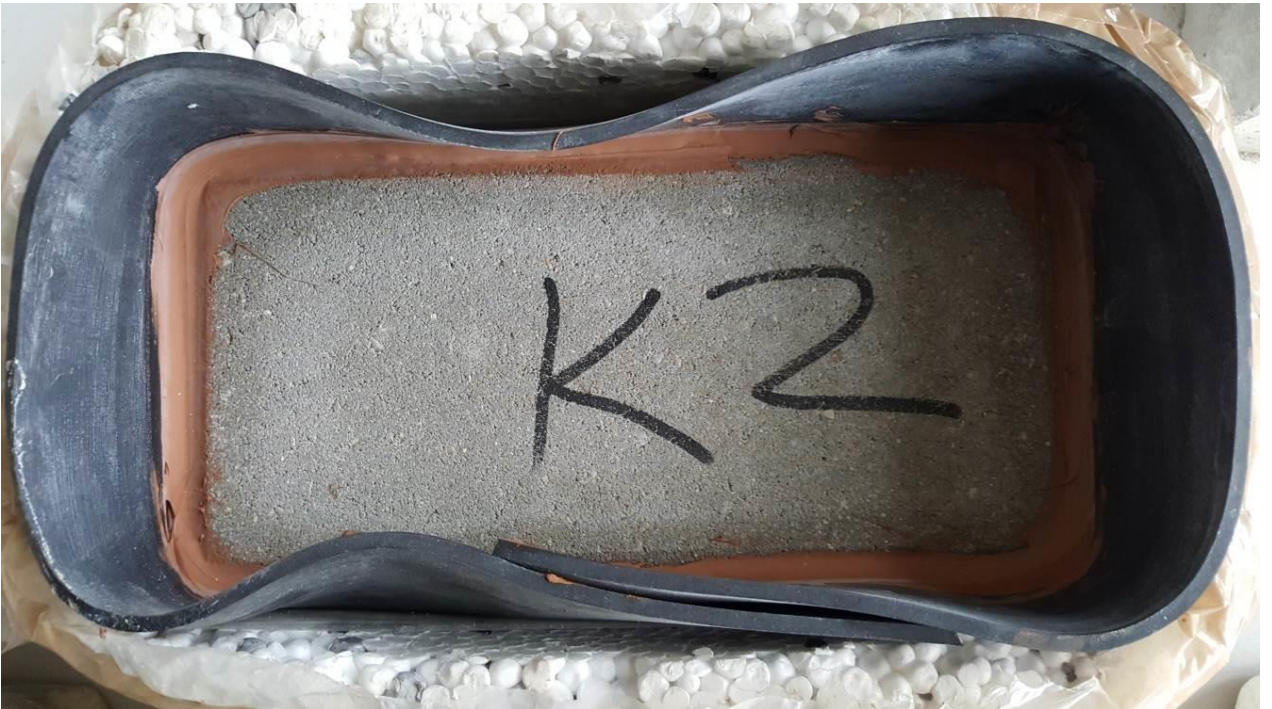
8 Figure Block K2 before the freeze/thaw testing (top) and after 72 days of testing (bottom)

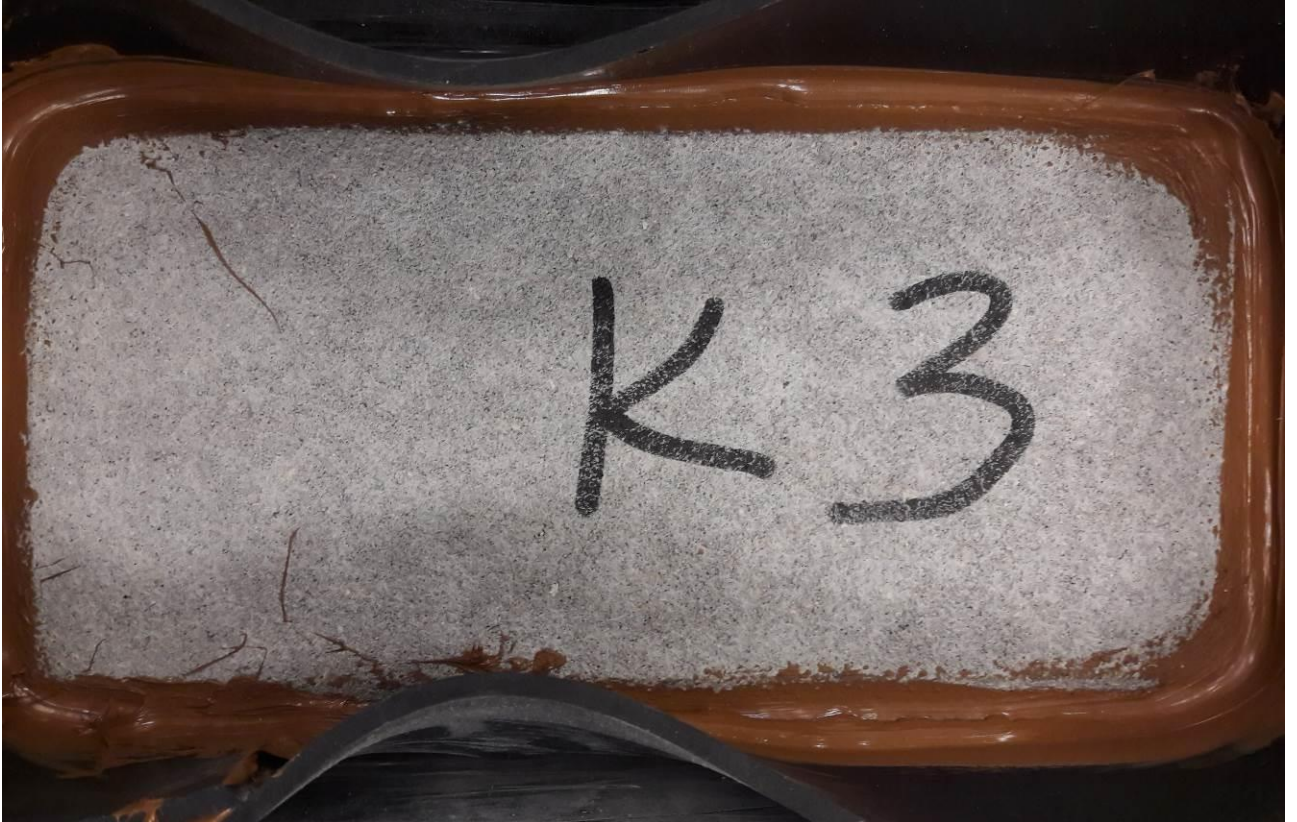
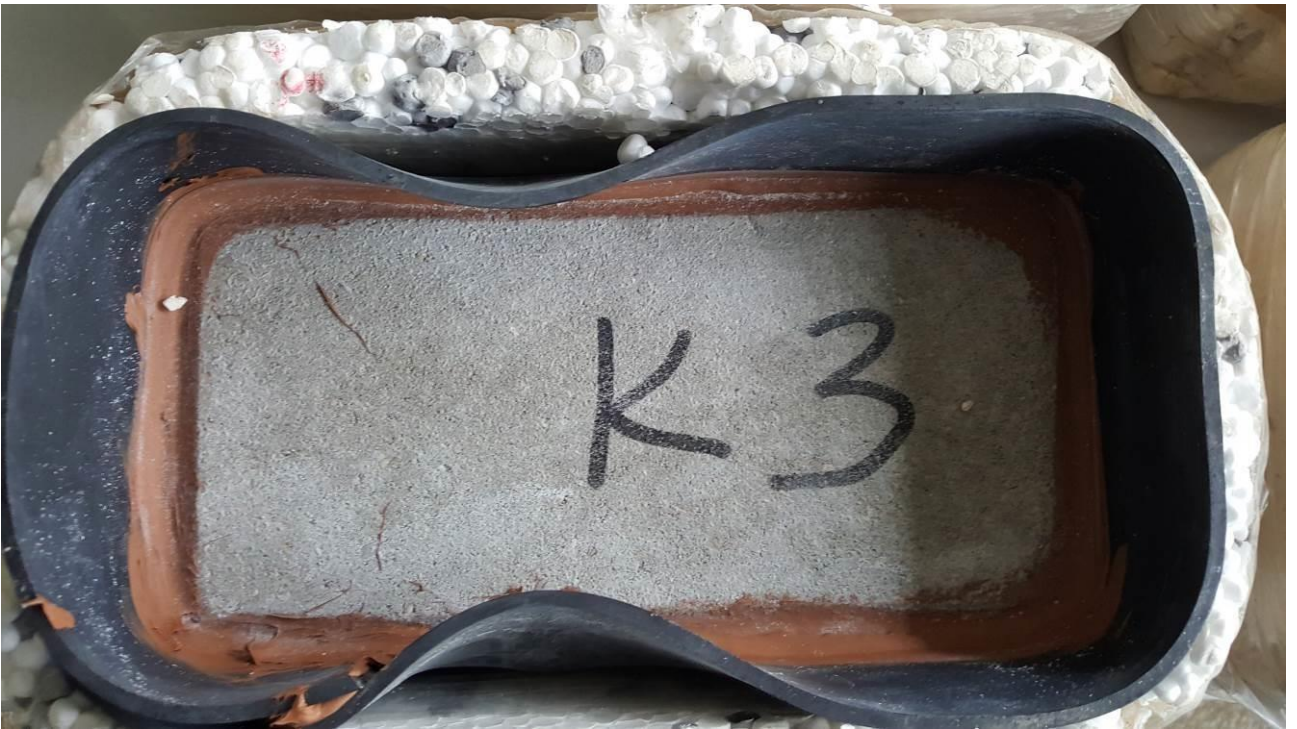
9 Figure Block K3 before the freeze/thaw testing (top) and after 72 days of testing (bottom)

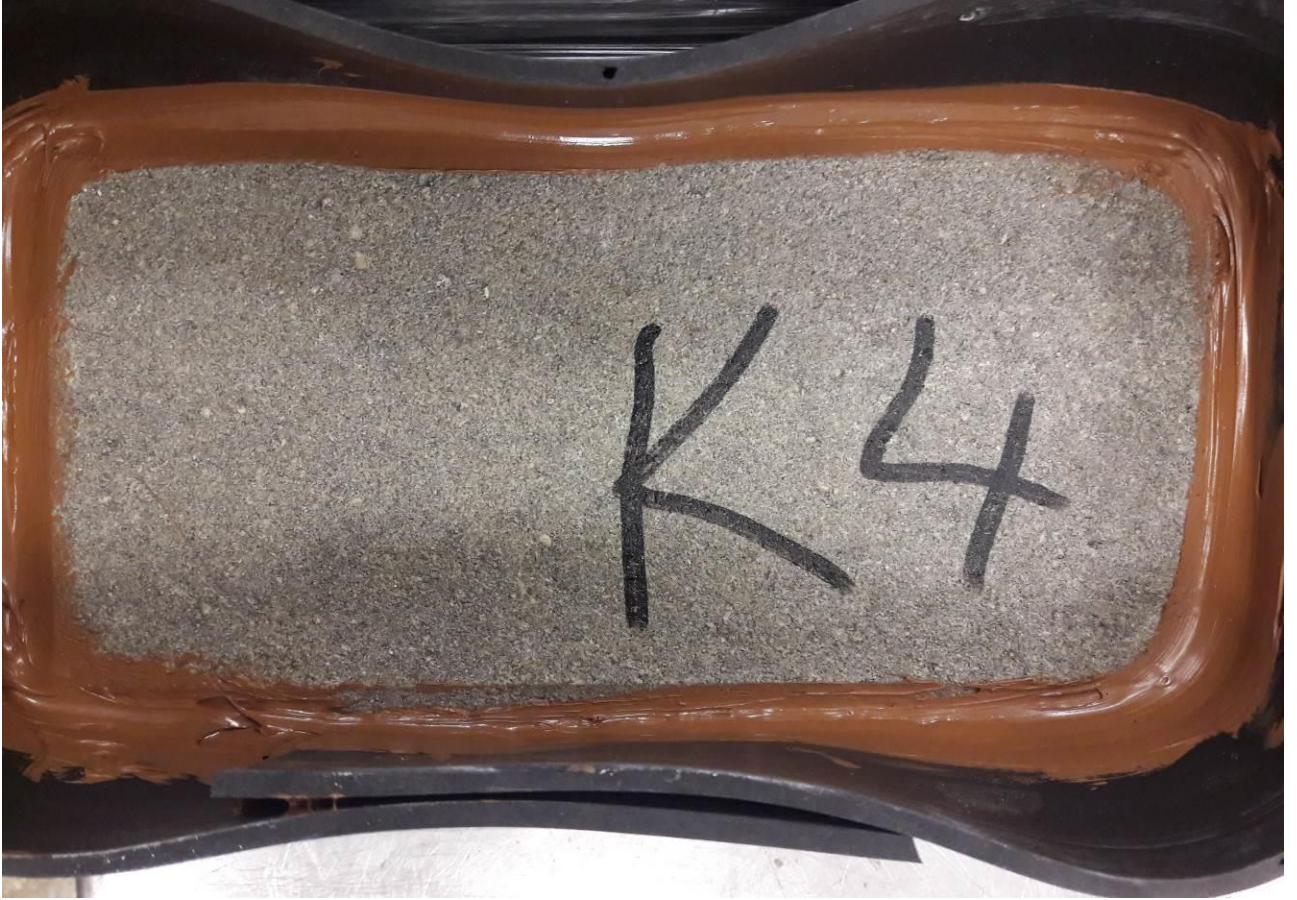
10 Figure Block K4 before the freeze/thaw testing (top) and after 72 days of testing (bottom)
